AUCHMEDDEN CHURCH, PENNAN

EXPLORING PAST AND PRESENT

**DAMAGE, DETERIORATION AND
DESPAIR!**

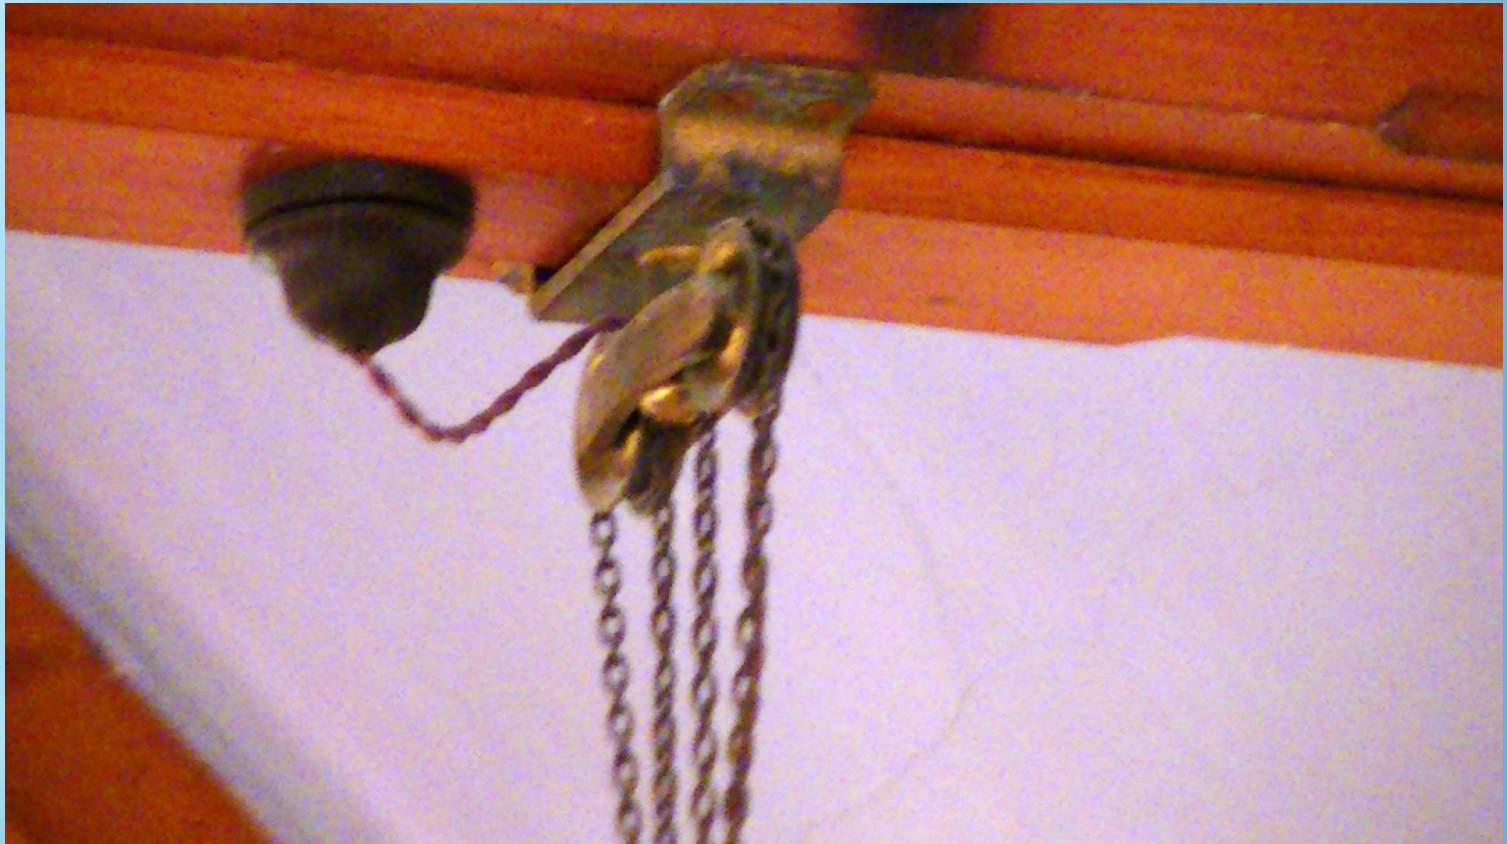
Pulley system for the paraffin lamps.

The brass light fittings were in fact the original carriers for the paraffin lamps before they were wired for electricity. At the top of each light fitting you can still see the pulleys that were used to raise and lower the lamps for lighting. The ropes and pulley system are still there up above the church ceiling – they ran down to the back of the balcony.

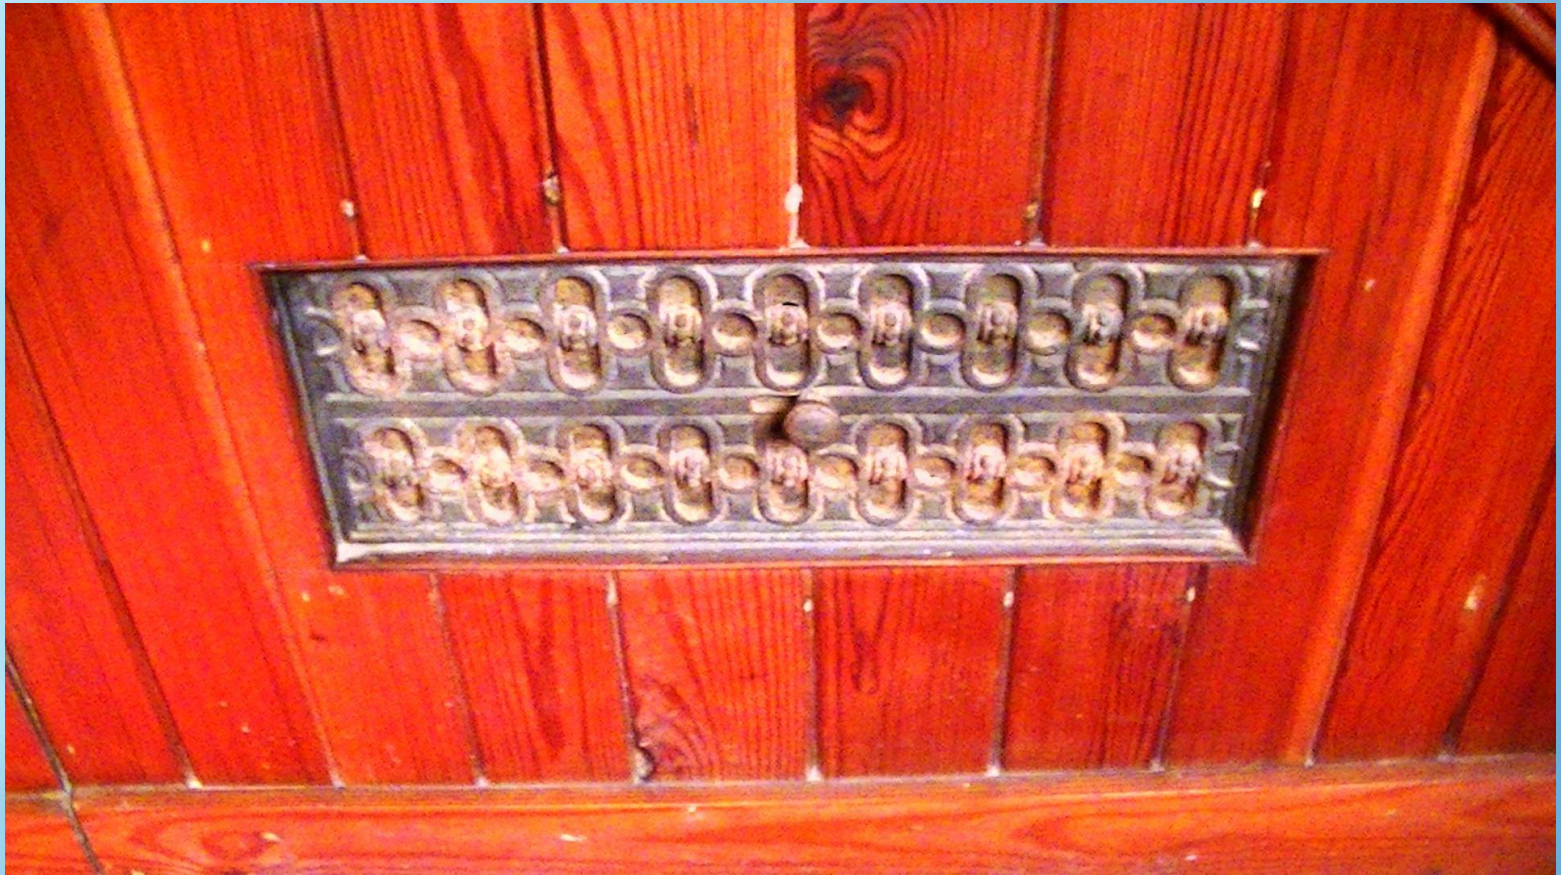
Looks like a ventilator on the side of the pulpit but it's actually connected by a wooden duct to a heating chamber below the church. It's unclear what sort of fire they used because the chamber is partially bricked up. It would seem to have been pretty basic though – just a big fire with the heat rising by convection up through the church. Apparently it was never a success because it channelled up smoke as well as heat!

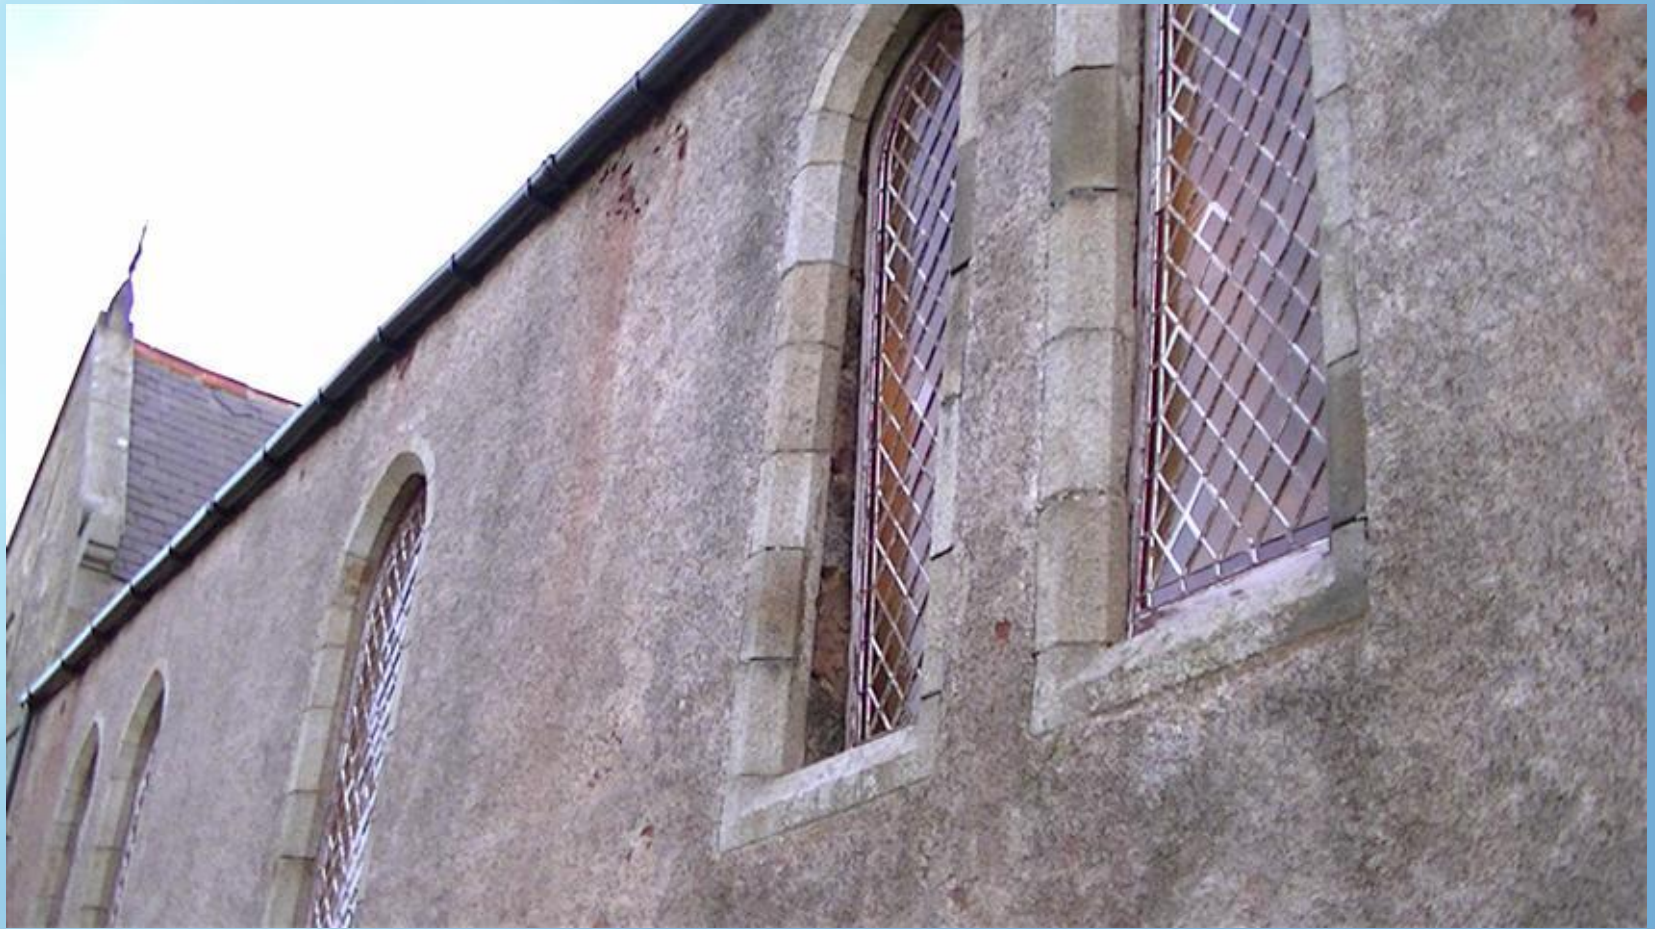
In September 2012 a severe gale blew in one of the windows at the front and for a start this seemed to be all the damage – apart from a few slates off the roof.

On closer examination, however, it became clear that the force of the wind had got in behind the wall and pushed it away from the stonework, so that a large and dangerous looking bulge had appeared inside.

We got estimates for repairs – two contractors didn't want to touch it and other two estimated £12372 and £8012 The insurance argued there must have been 'wear and tear' so all they were prepared to pay was £3215

Because the wall was unsafe it was looking as if the building would have to close.

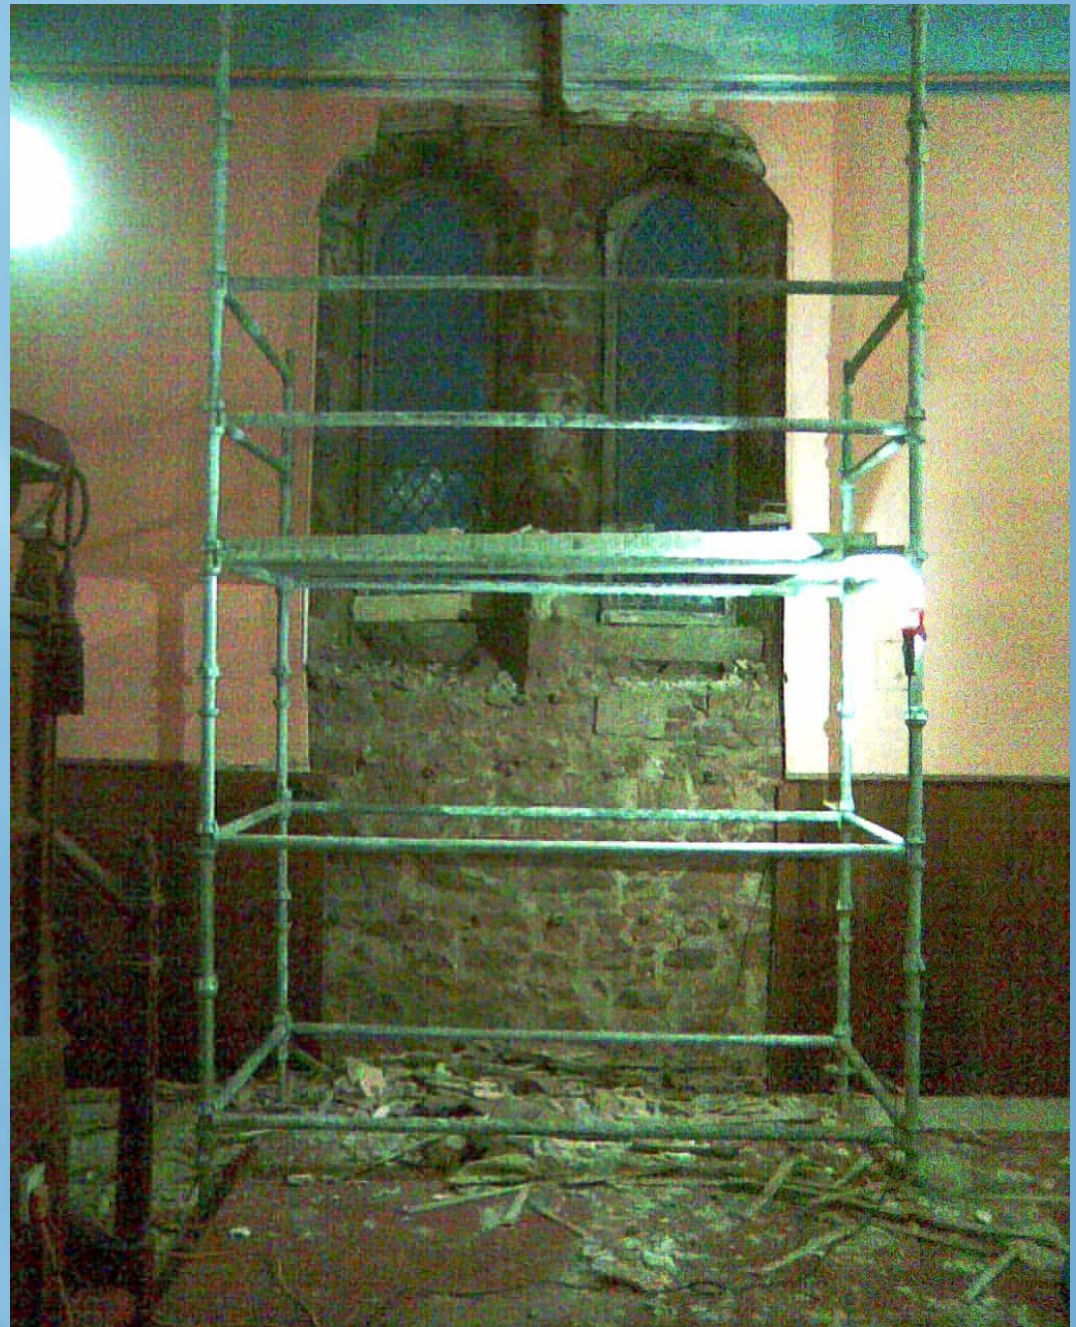
Downstairs, the sides of all the windows had to be re-lined.

The upstairs was in a particularly bad state – the walls were collapsing, the windows were hanging out and because there was no hope of even patching things up all three walls had to be pulled down and disposed of.

Obviously this produced a huge amount of rubble and we couldn't look at the price of a skip so we cut a hole in the downstairs floor and dumped everything underneath! Fortunately there is a pretty large void – especially at the sea side!

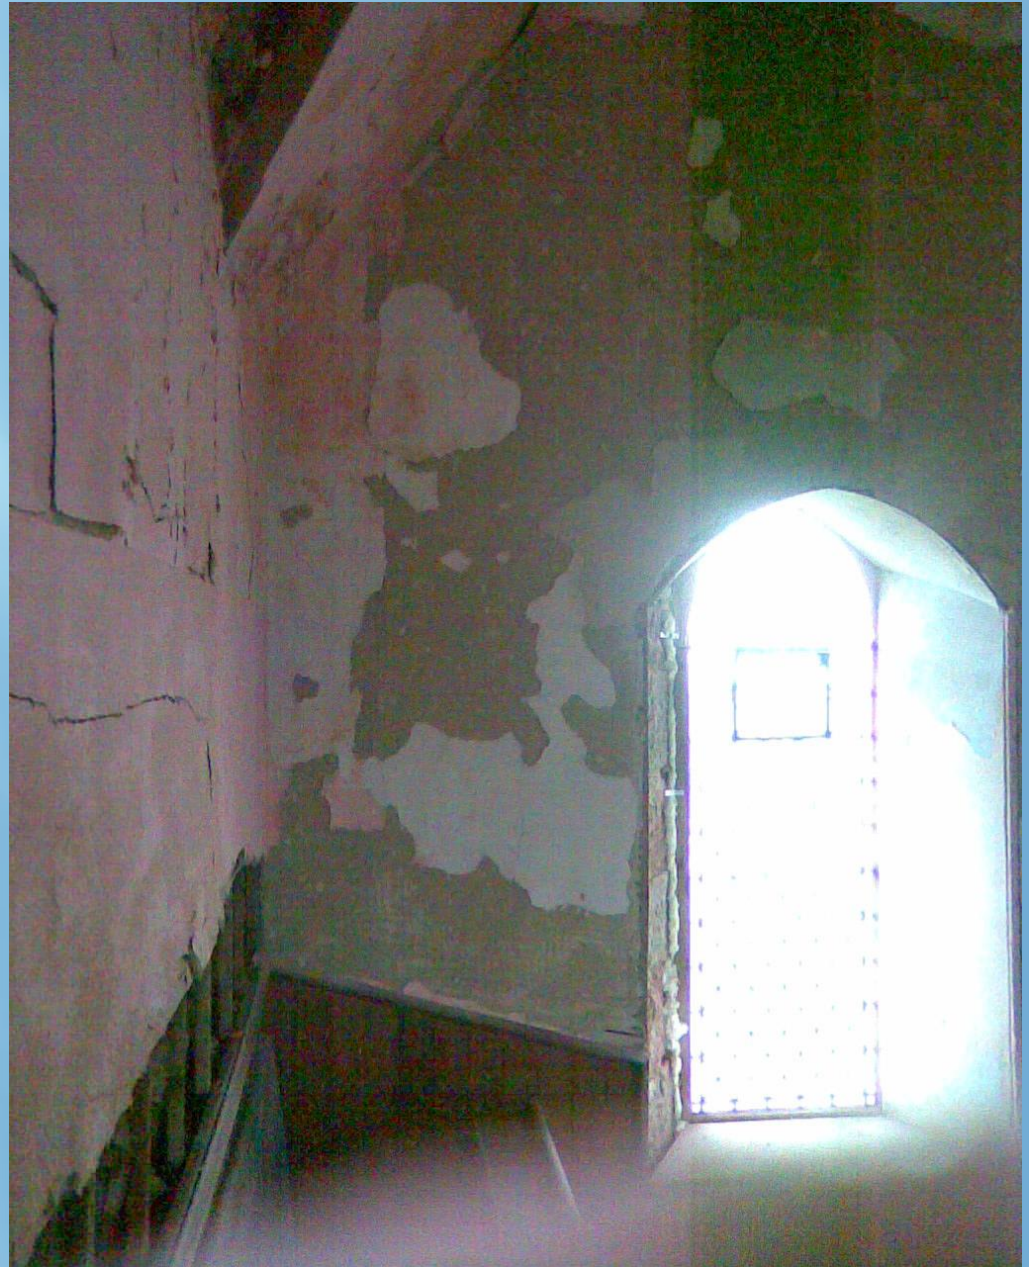
The whole of the upstairs and the stairwell had to be gutted back to the stonework before putting up new posts and plasterboard.

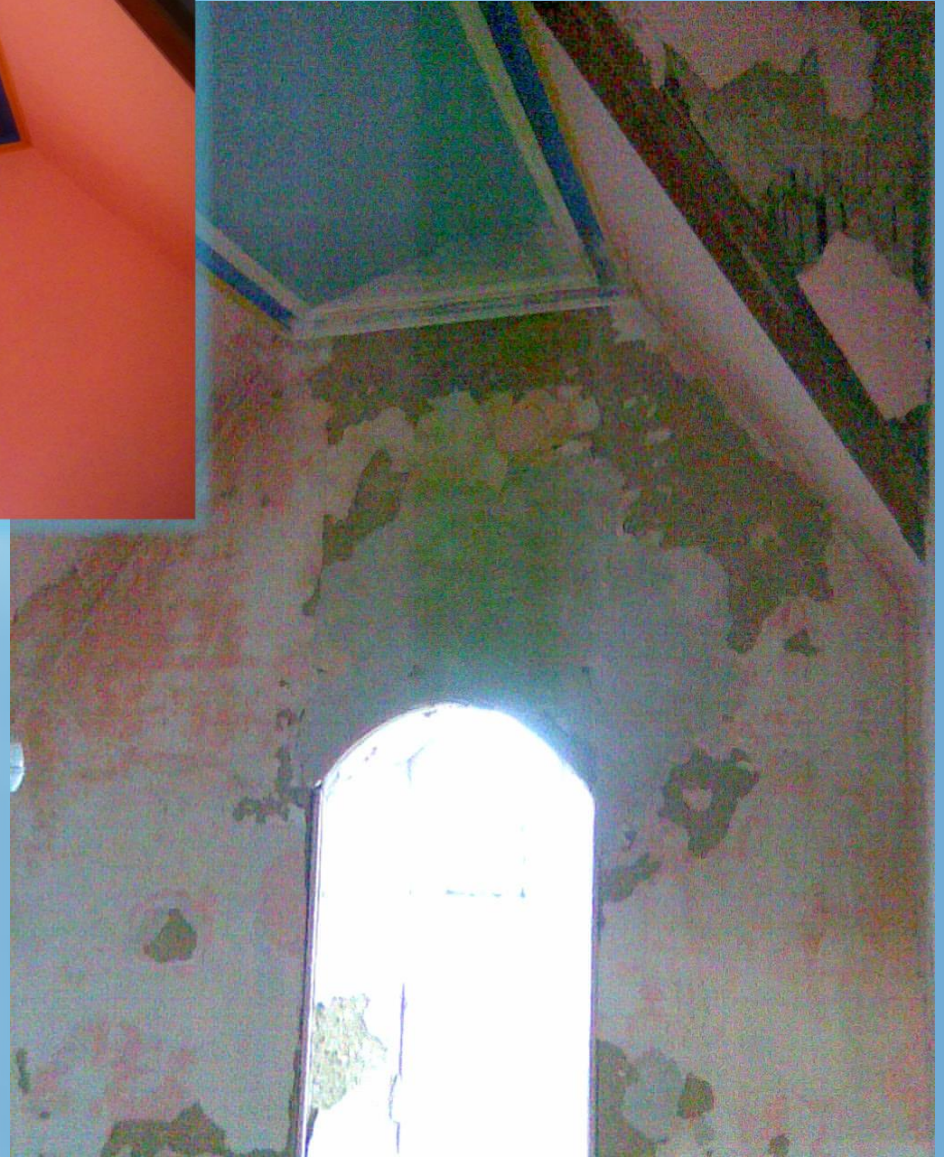
Upstairs was completely re-lined and the ceiling and cornices were re-plastered as needed. In total we went through 37 sheets of plasterboard!

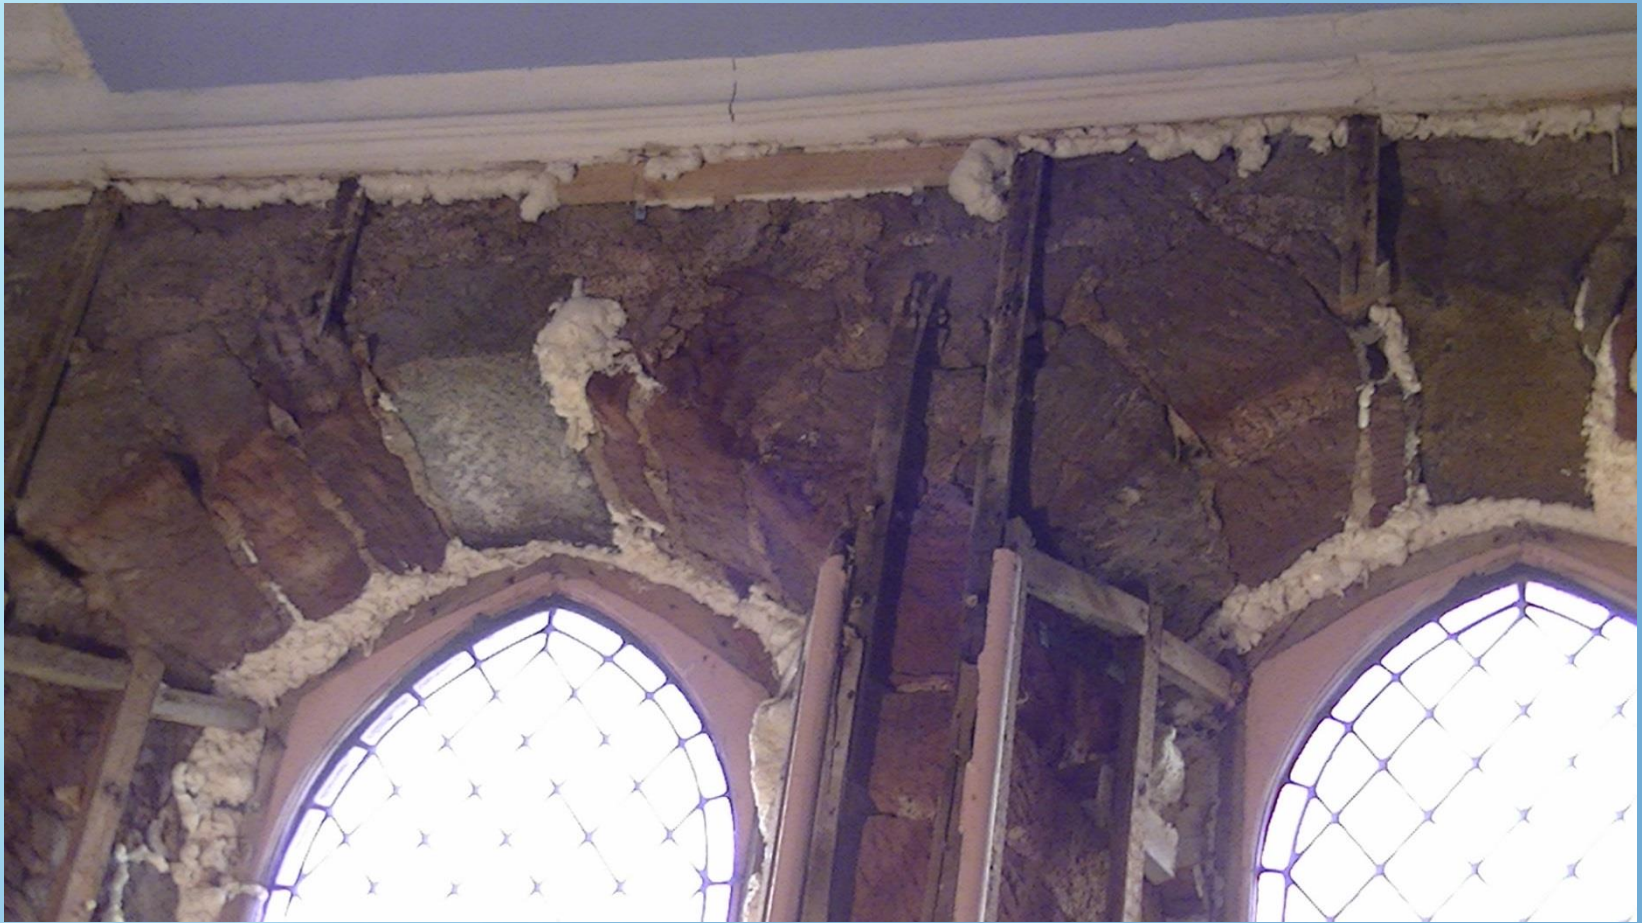
The upstairs windows were falling out (during the winter of 2013-14 they had to be propped up inside with a pole tied to the end of a pew!) They were fixed back to the stone with metal straps then sealed off with expanded foam inside and silicone sealer outside.

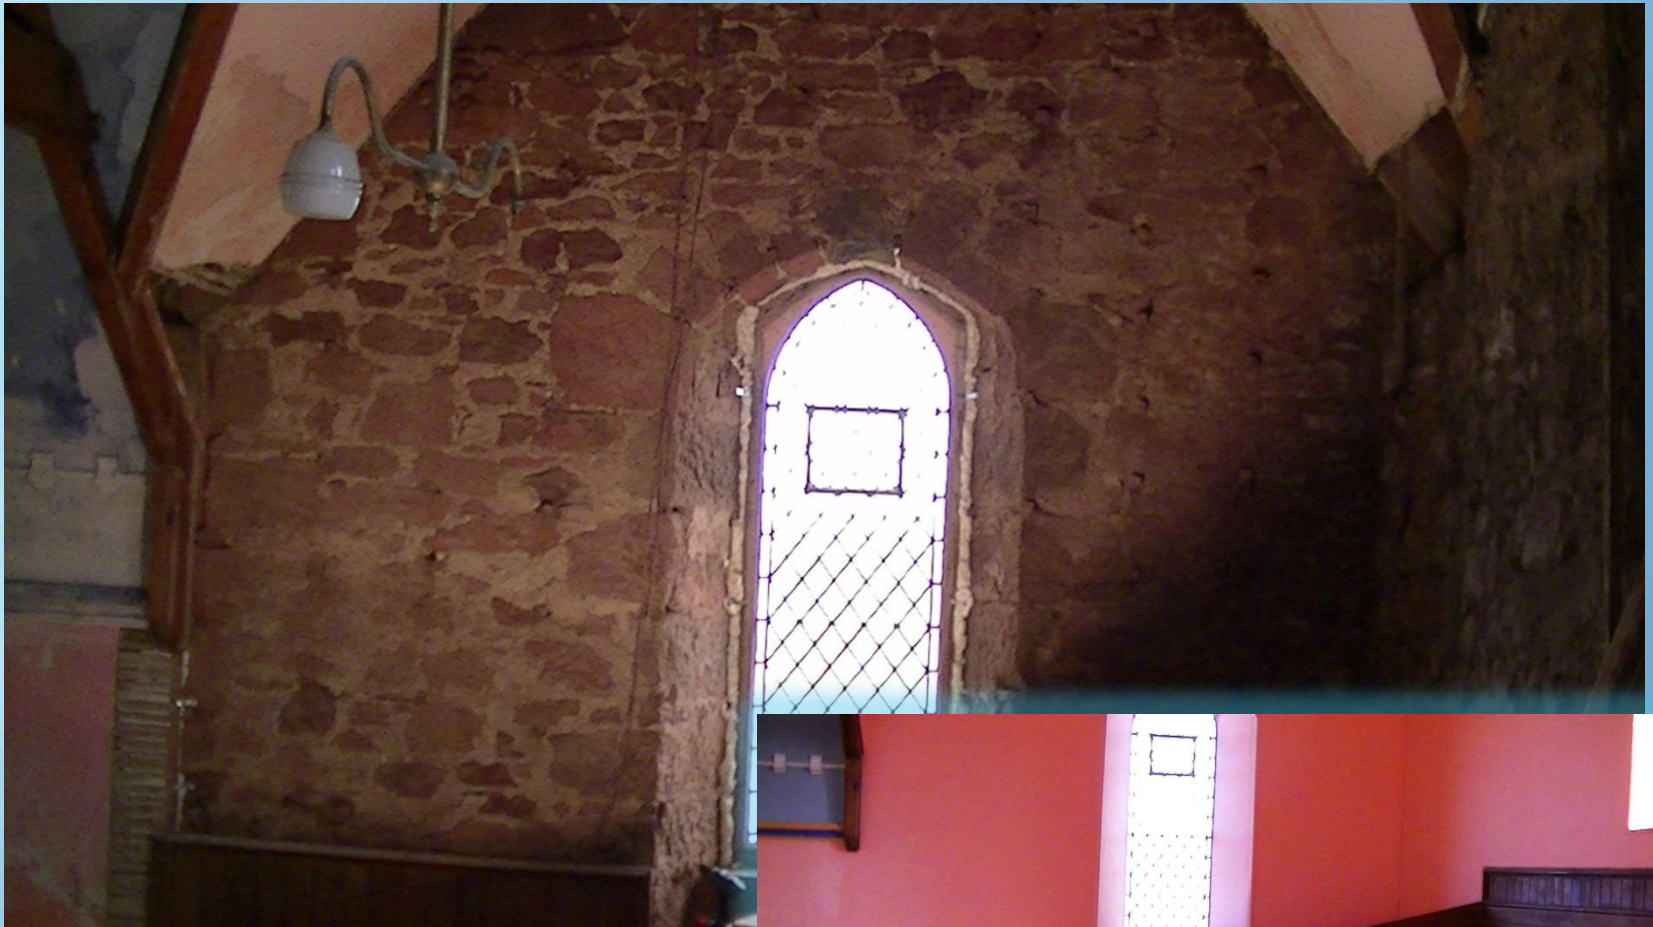
**The stairwell stripped and ready
for new linings.**

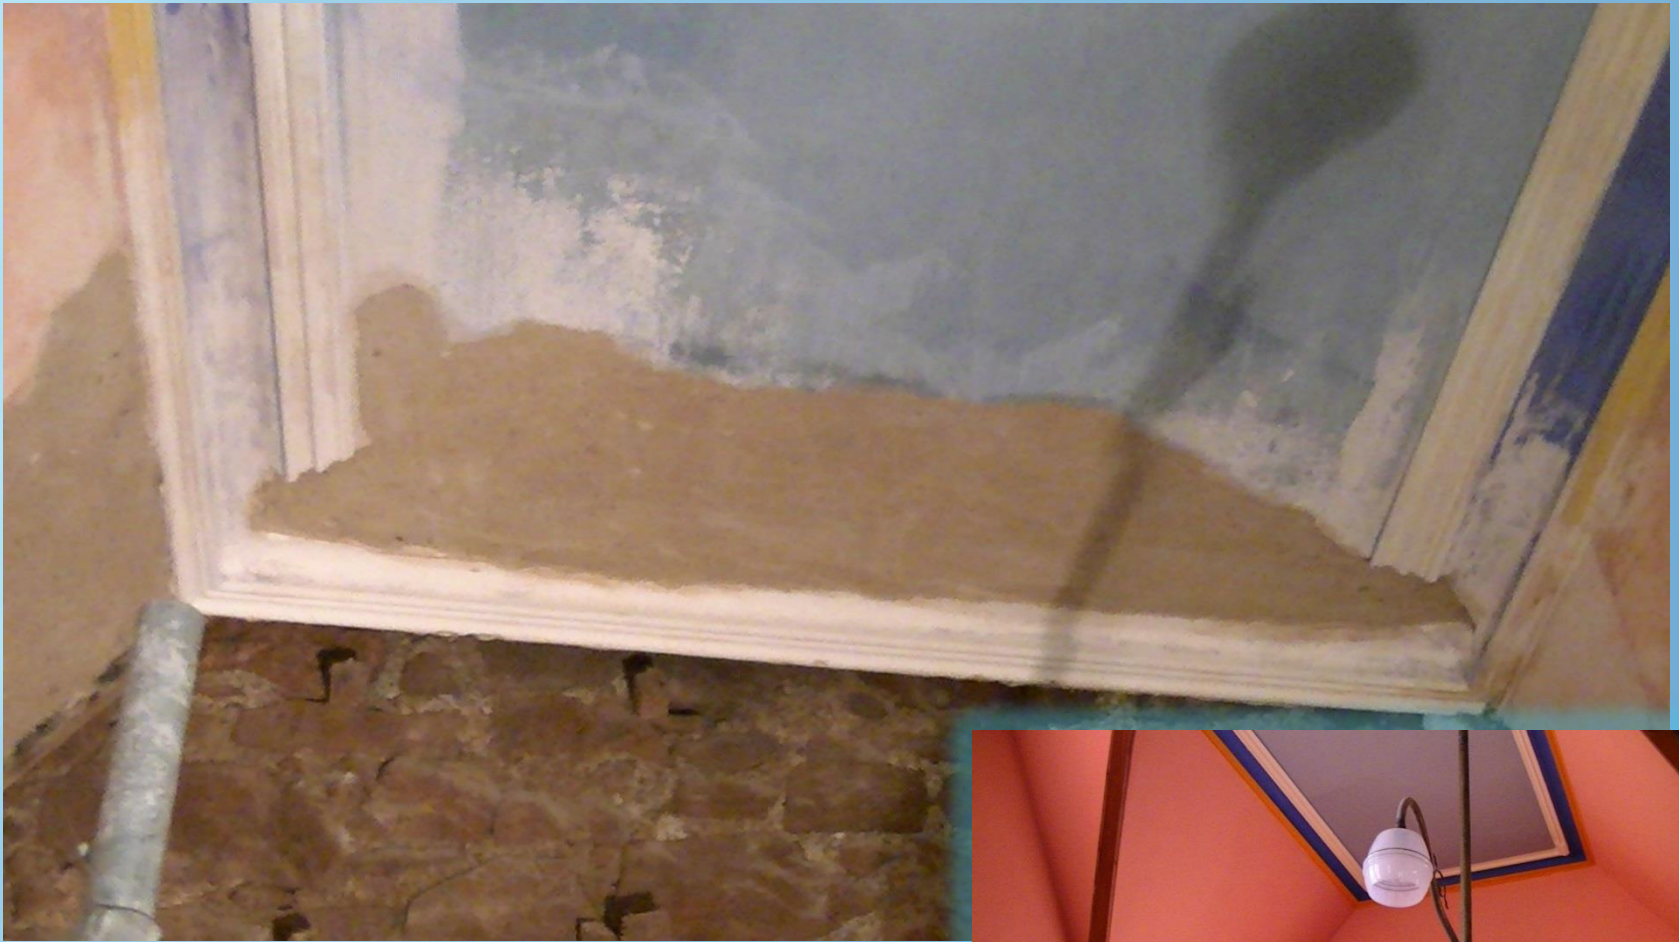
Plasterwork on the upstairs ceiling.
